## **Demonstration of Corrosion-Resistant Coatings for Air-Conditioning Coils and Fins**

Final Report on Project F10-AR01

Alfred D. Beitelman and Susan A Drozd

June 2015

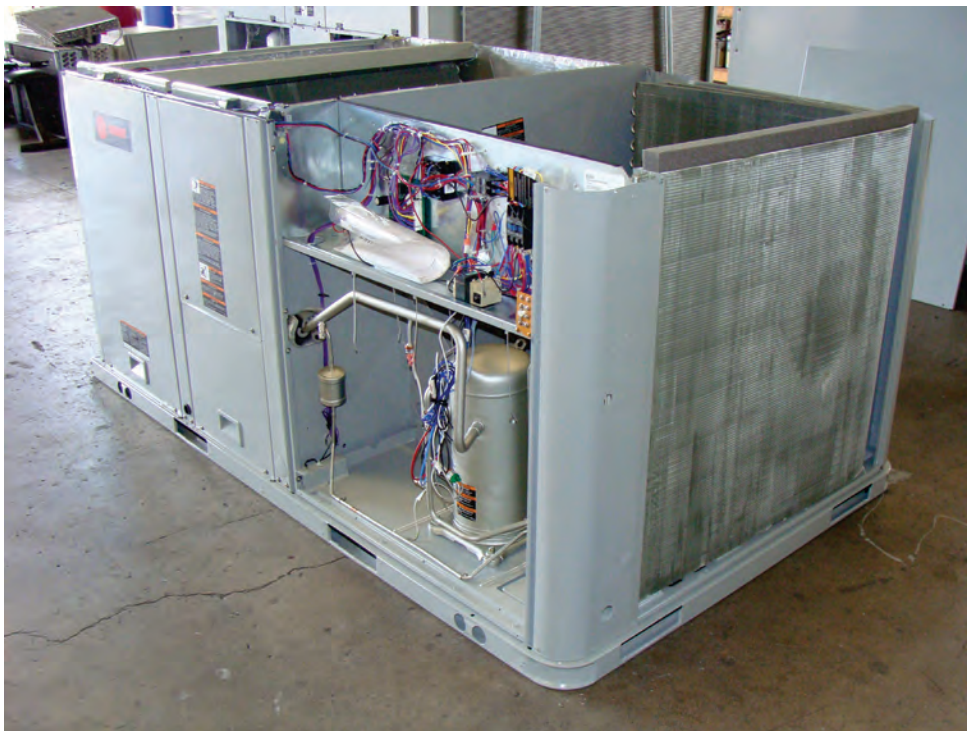
Figure 1. Interior layout of a Carrier-brand condenser, shown with coated fins.

An AC coil is a heat exchanger that permits controlled transfer of thermal energy between different media such as the ambient air and a volatile fluid coolant (e.g., refrigerant) inside the coil. The coil's fins enhance the efficiency of the heat transfer to the air. (A standard AC condenser and evaporator coils consist of serpentine tubing surrounded by and attached to thin metal fins.) The tubing and fins may be of aluminum or copper, and they may or may not be coated. A compressor pumps the refrigerant between the evaporator and the condenser elements within a closed system. The liquid refrigerant evaporates inside the indoor evaporator coil as it absorbs heat from the indoor environment, reducing the temperature in the conditioned space inside the facility. The heated refrigerant gas is pumped outdoors to the condenser where it releases heat through the heat-exchange tubing and fins, condensing back into its liquid form for cycling back into the interior space. Figure 1 shows a condenser unit's interior layout.

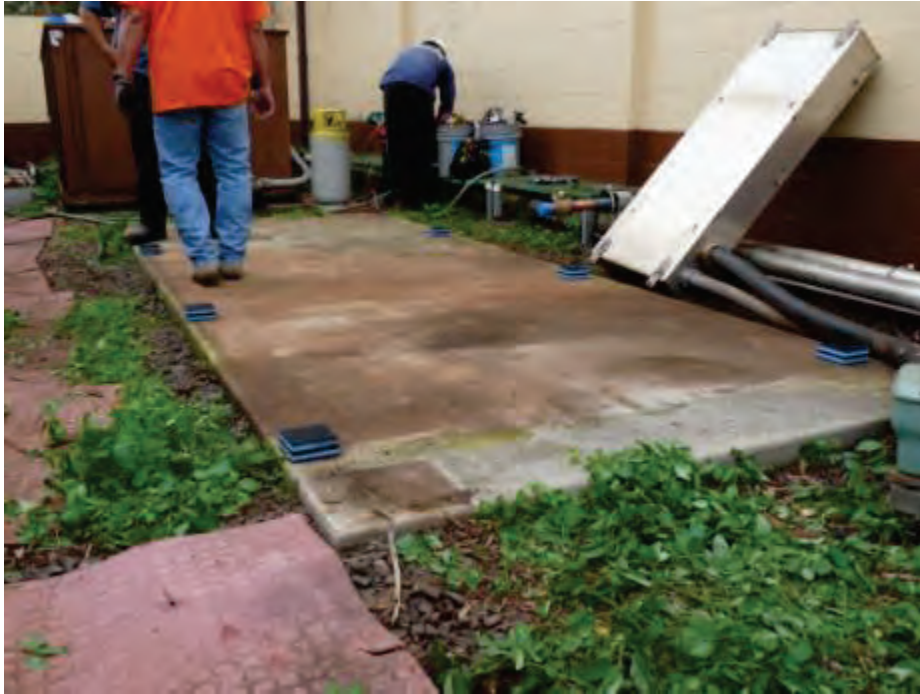
Figure 2. A condenser area cleaned of debris, with new footings in place.

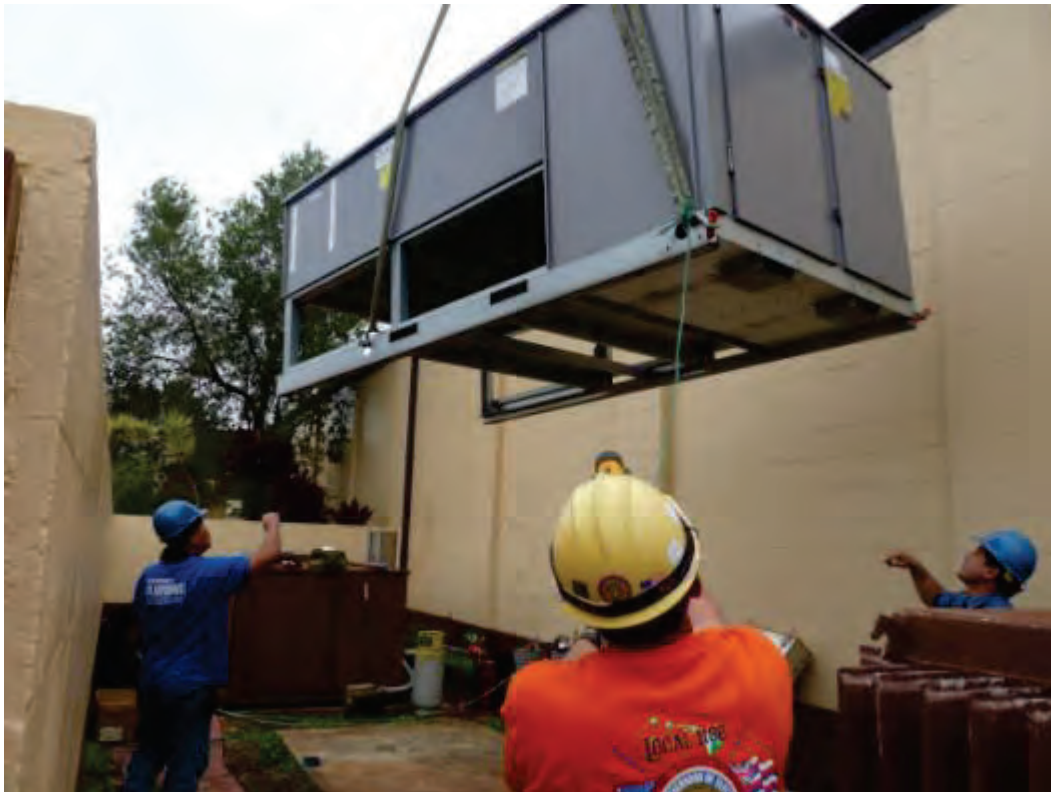
Figure 3. Positioning one of two new condenser units outside Schofield Barracks Bowling Center.

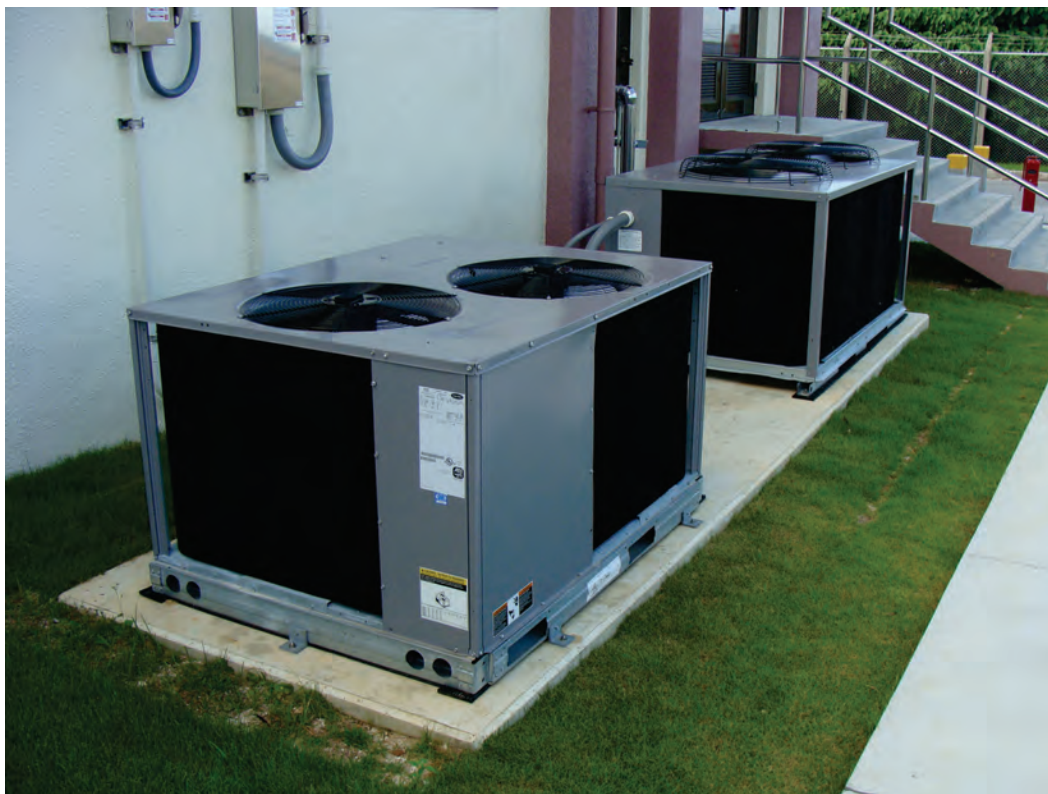
Figure 4. Two units in side-by-side configuration as installed at Schofield Barracks Bowling Center.

The removal and replacement operation for each condenser was conducted during two separate weeks to avoid interruption in the bowling center's operation and to minimize impacts on the air-conditioning system's load while one unit was down. Prior to removing each existing condenser, power was disconnected from the unit and refrigerant liquids were vacuum-drained from the system. All copper plumbing connected to the interior units of each AC system was cut away to allow for the existing condenser's removal. A crane was used to lift the existing unit over the block retaining wall. Once the existing condenser was removed, the area was cleaned of all debris and new cushioned footings were installed for the new condenser. The crane was used again to lift the new condenser over the retaining wall and position it on the footings. New copper plumbing along with new refrigerant ball valves were installed and connected to the interior systems. Upon completion of the plumbing installation, new R-22 refrigerant was pumped through the system and primed. Electrical power was connected to the unit, and it was commissioned. This process was repeated for the second unit. Figure 2 and Figure 3 show the location of one of the units and its installation. The two condensers were located adjacent to each other outside the Schofield Barracks Bowling Center, as shown in Figure 4.

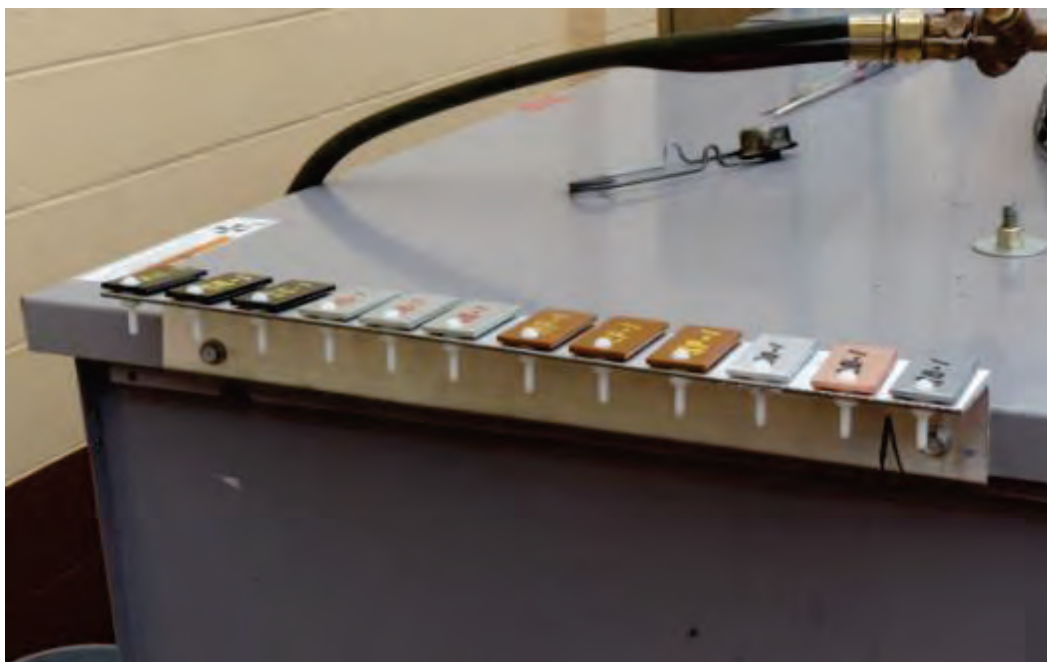
Figure 5. Aluminum coupon rack was fabricated to hold 12 coupons and mounted at each of the two condenser sites.

An aluminum exposure rack was fabricated for placement at each of the two AC condenser locations (Figure 5). Each rack was designed to isolate 12 coupons that were 1 in. wide x 2 in. long x 1/8 in. thick from any galvanic effects of other metals. Each rack contained four copper coupons, four 1010 steel coupons, and four 2024-T3 aluminum coupons. A single coupon of each material was coated by Carrier with Coating E. Similarly, a single coupon of each material was coated by International Air Conditioning Coatings with Coating B, and IFM Effector, Inc. of Exton, Pennsylvania, coated coupons of each material with the phenolic coating commonly used by Carrier for condensers in less-corrosive environments. The remaining coupons were left bare. Each coupon used in this program was printed with a distinctive code indicating: (a) the substrate, (b) the coating, and (c) a consecutive number for the system. The coupons and each condenser unit were photographed and assessed at 12 months and 24 months after installation. Additional photographs of the on-site coupon racks are shown in Section 3.2 and the appendix of this report. Observations of blistering

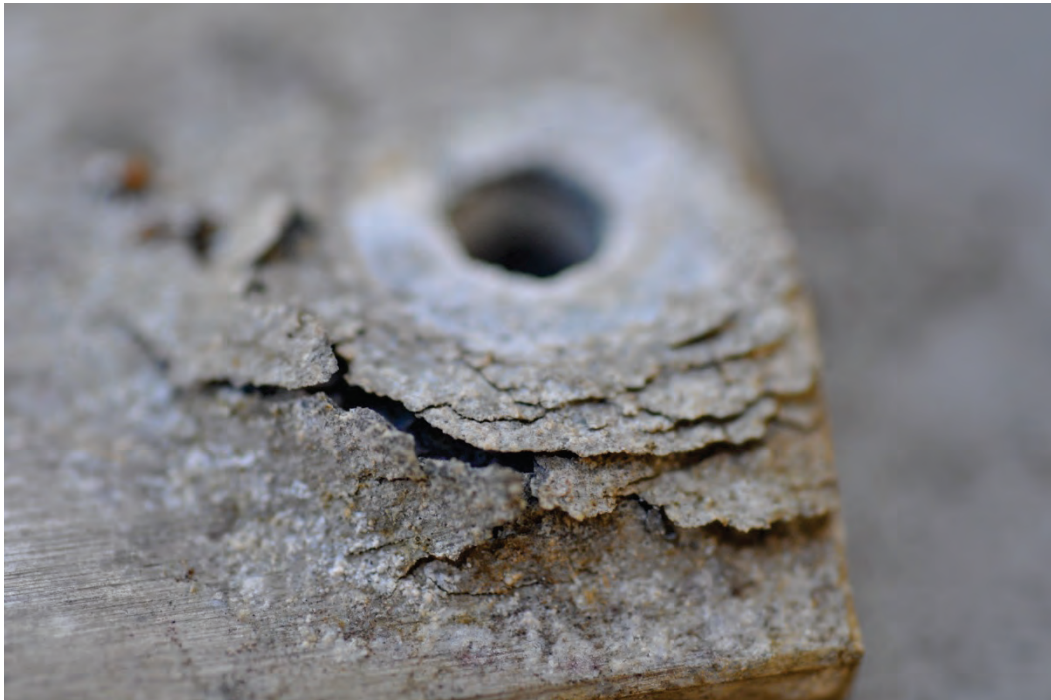
Figure 8. Exfoliation of a bare aluminum coupon after 24 months of on-site field exposure.

- The phenolic coating and Coating B failed to protect the steel substrates at both of the on-site locations.
- Rust and blistering were most prominent on the edges of each coupon.
- Blistering on the aluminum and copper coupons was substantially less.
- The phenolic coating adhered better to the aluminum and copper coupons than did Coating B and Coating A.
- The uncoated coupons showed severe signs of corrosion on 100% of the material within 12 months of exposure.
- The bare aluminum coupon on Rack 2 began to crack and separate into layers from exfoliation corrosion, causing the coupon to break away from the nylon fastener (Figure 7).
- The uncoated aluminum surface of the condenser exterior showed significant corrosion after 24 months of exposure (Figure 8).

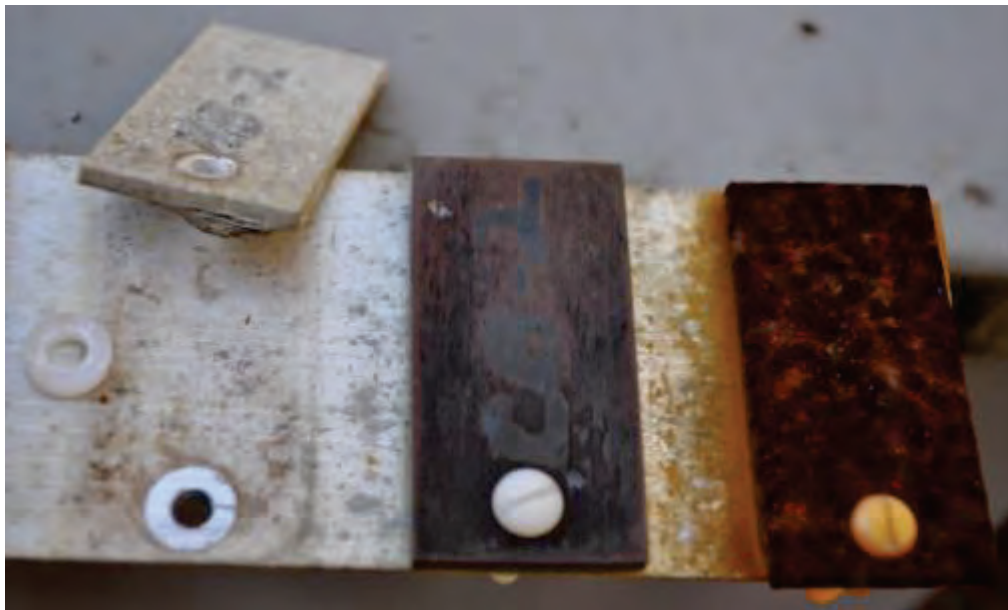
Figure A24. Rack 2, bare coupons at 24 months.  
Note that aluminum coupon (at far left) has become detached.

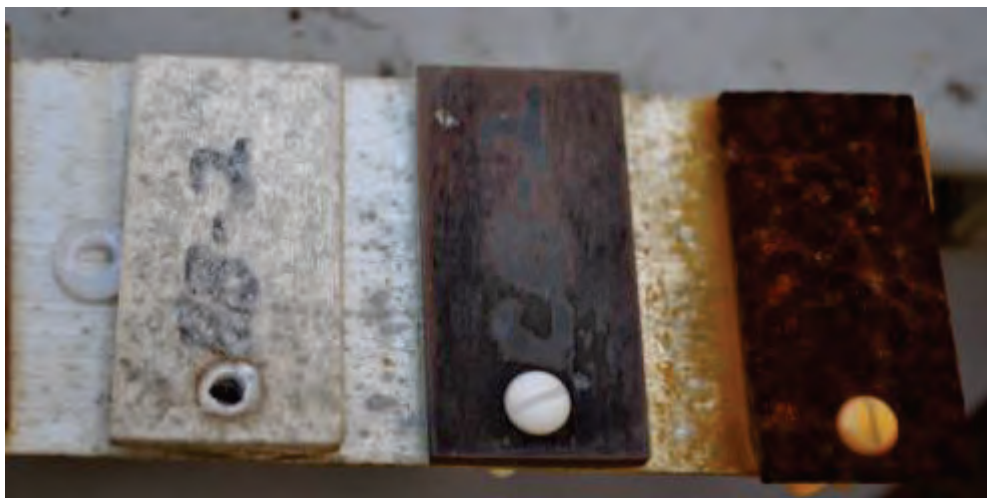
Figure A25. Rack 2, bare coupons at 24 months (photo 2).  
Note that this photo was taken after aluminum coupon was repositioned.
